Appendix M

Photos

Campgrounds

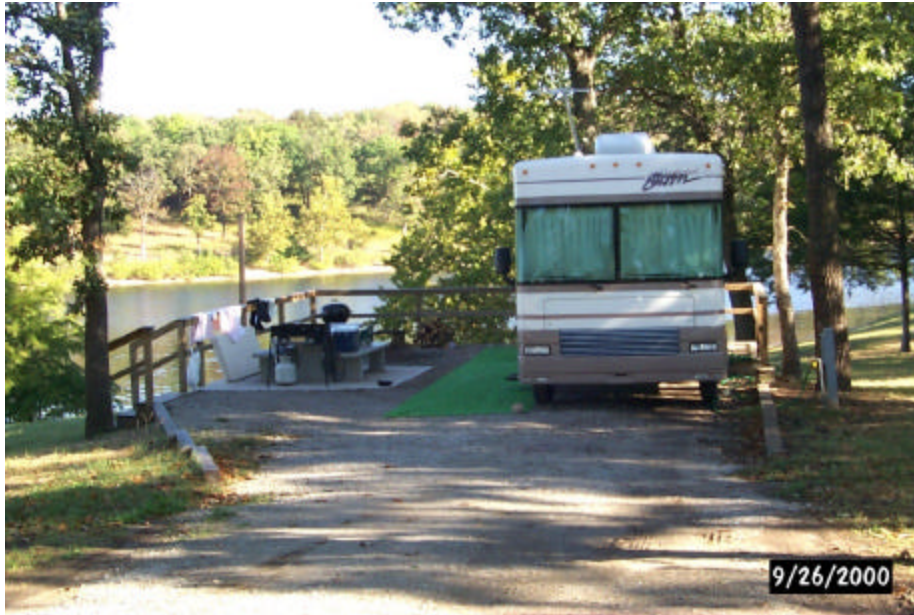
Photo M-1. Shaded and water-oriented campsite. Pomme de Terre Lake, MO. This campsite satisfies customer preferences for shade and proximity to the lake or river (Table 5.1 and Para. 5.3)

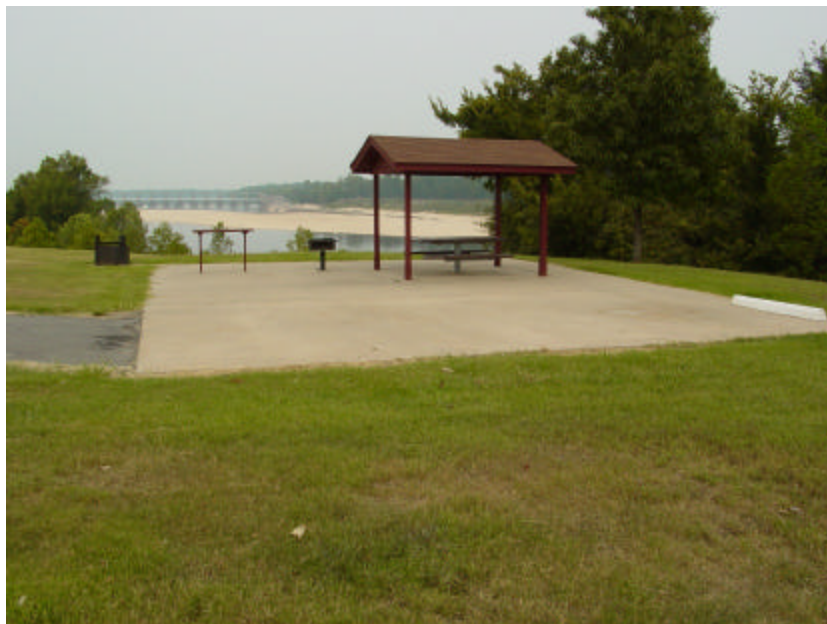
Photo M-2. Shaded UA campsite. Wilbur D. Mills Park, Pine Bluff Project, AR. This campsite is UA (Para. 5.2.1) and has a shelter to provide shade since existing vegetation is not available (Table 5.1)

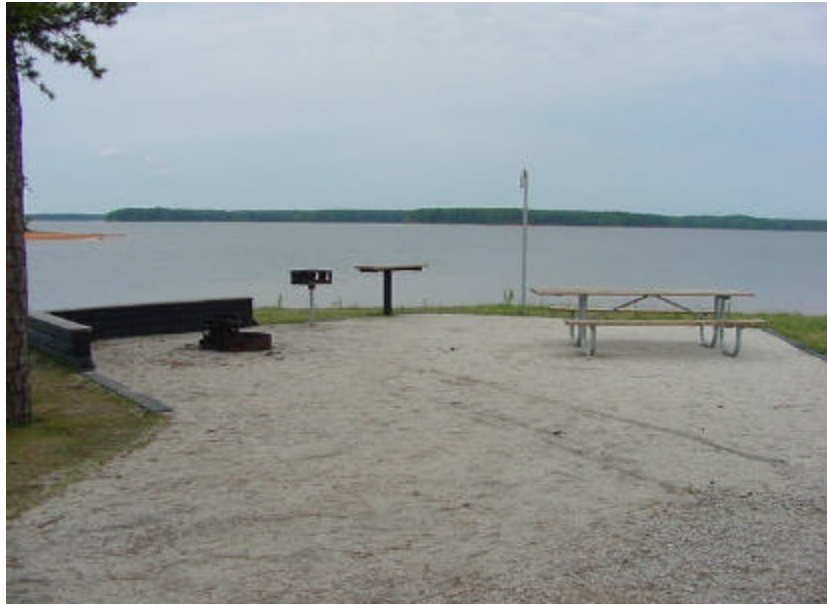
Photo M-3. Campsite amenities. Modoc Campground, J. Strom Thurmond Lake, SC. View of typical campsite amenities, to include utility table, fire ring/grill, pedestal grill, lantern hanger, and UA picnic table (Table 5.2)

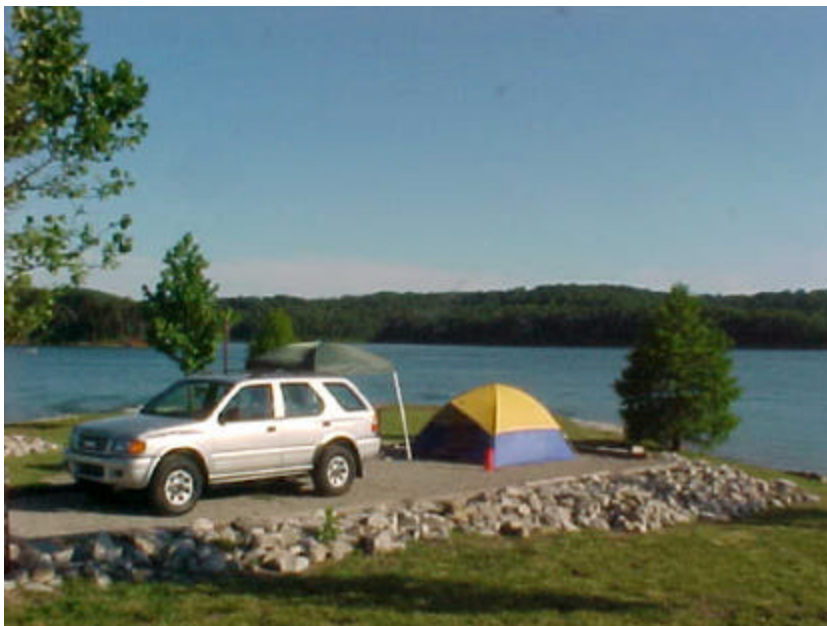
Photo M-4. Hardened living area. Moutardier Campground, Nolin River Lake, KY. Fine crushed stone surface provided (Para. 5.3.3.1)

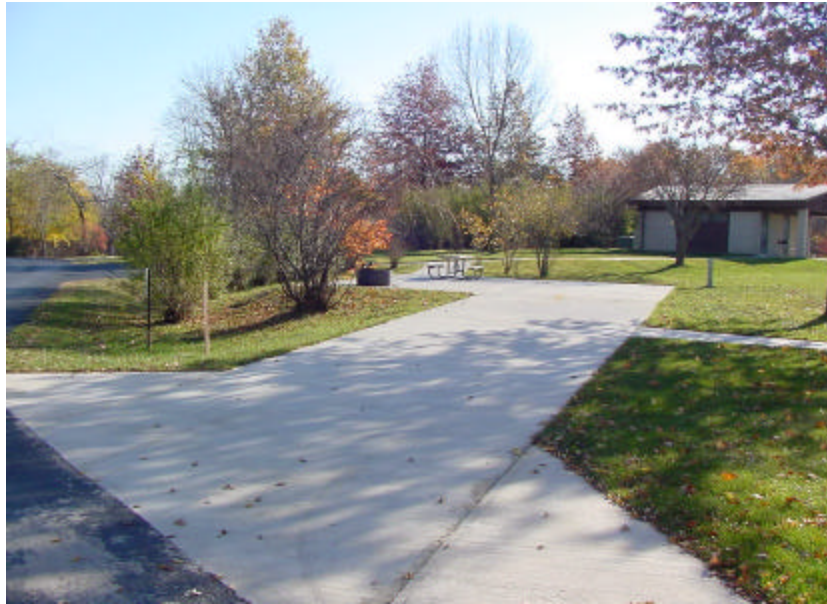
Photo M-5. Designated UA site, Example 1. Acorn Valley Campground, Saylorville Lake, IA. Fully concreted campsite (Para. 5.3.1)

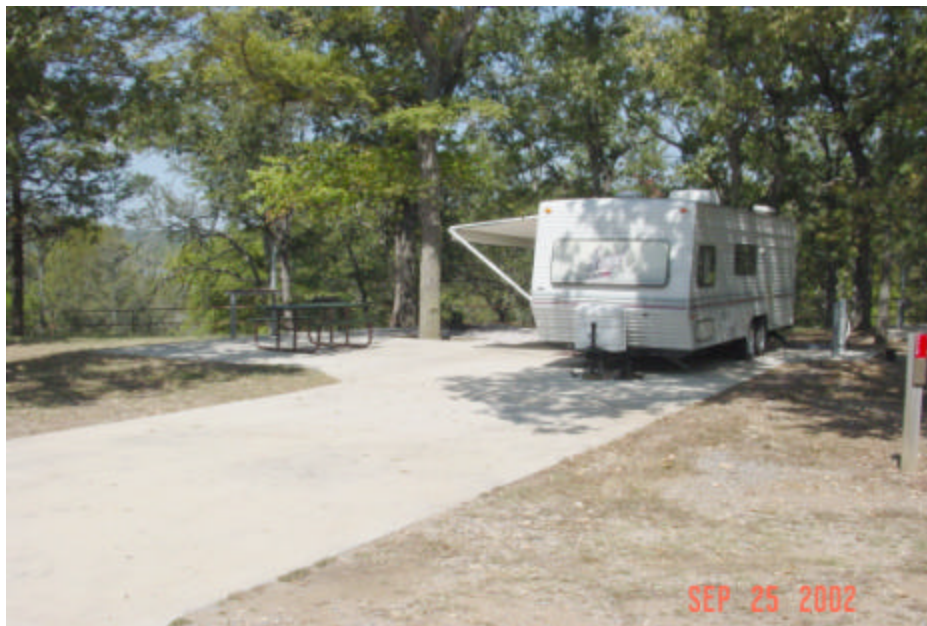
Photo M-6. Designated UA site, Example 2. Pettit Bay Recreation Area, Tenkiller Ferry Lake, OK. Fully concreted campsite (Para. 5.3.1)

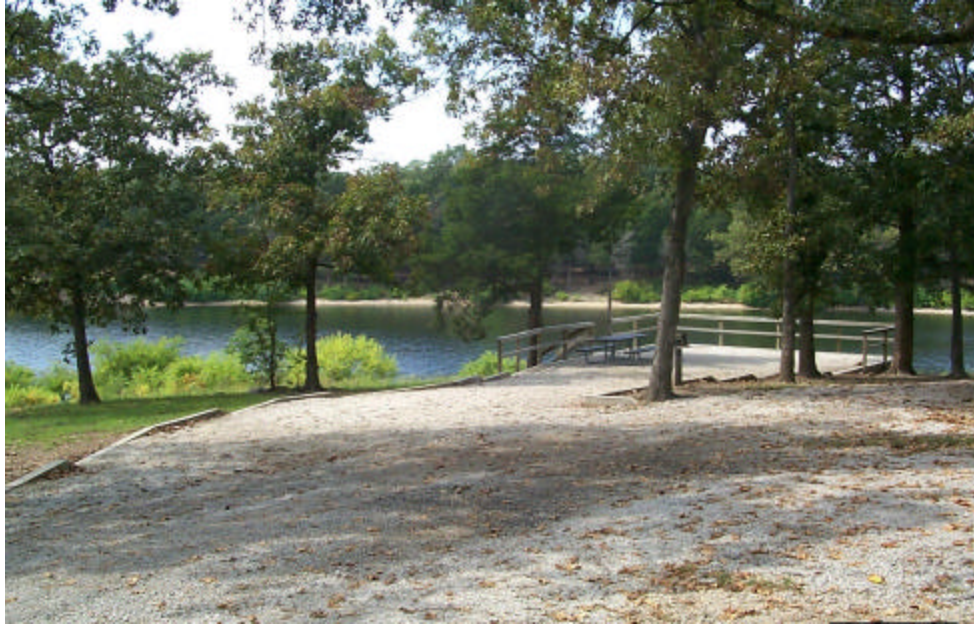
Photo M-7. Camping spur follows terrain - Example 1. Pomme de Terre Lake, MO. (Table 5.1). This photo also demonstrates hardened living area located on the passenger side, timber border, provision of room for RV slideouts, and required site amenities (Table 5.4)

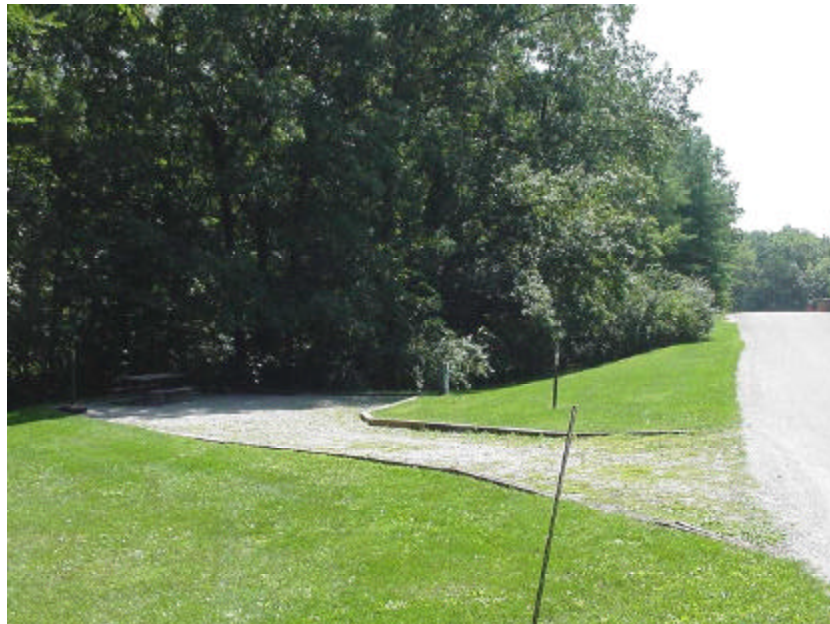
Photo M-8. Camping spur follows terrain - Example 2. Note how cut and fill are avoided by building this back-in site on the contour (Table 5.1)

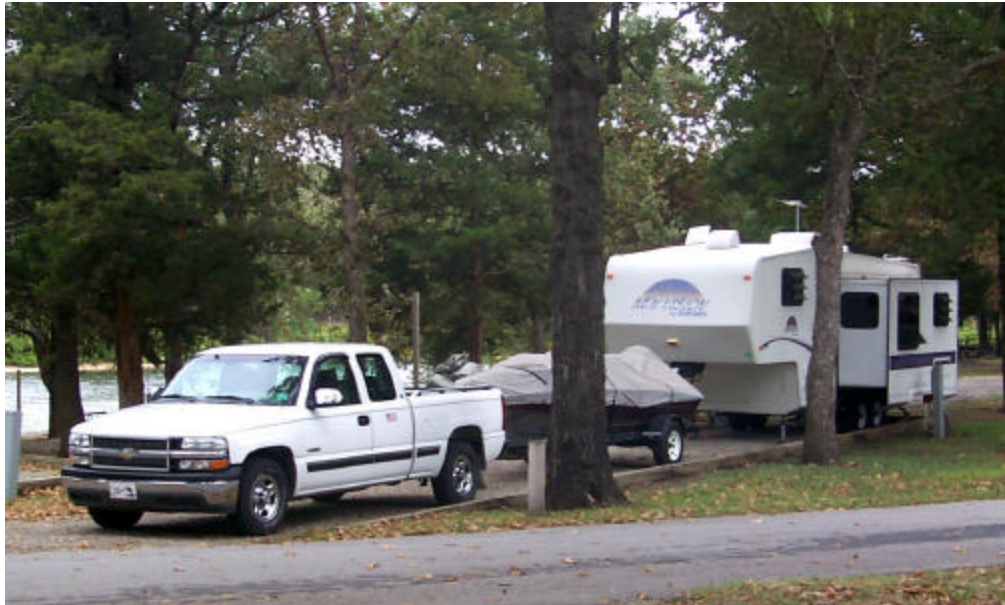
Photo M-9. Back-in site - multiple vehicles. Pomme de Terre Lake, MO. This photo demonstrates 70-ft spur length that provides additional parking space to accommodate car and boat trailer along with RV. Site provides room for RV slideouts (Tables 5.2 and 5.3)

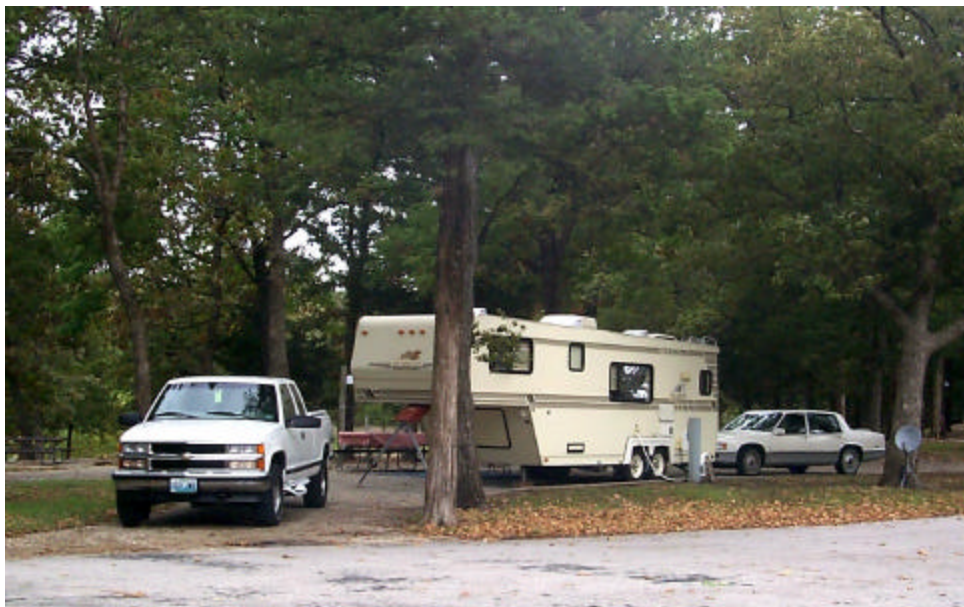
Photo M-10. Pull-through site - multiple vehicles. Pomme de Terre Lake, MO. This shaded campsite demonstrates 70-ft parking area length with room for extra vehicle, level and hardened parking area, and individual utility hookups (Tables 5.2 and 5.3)

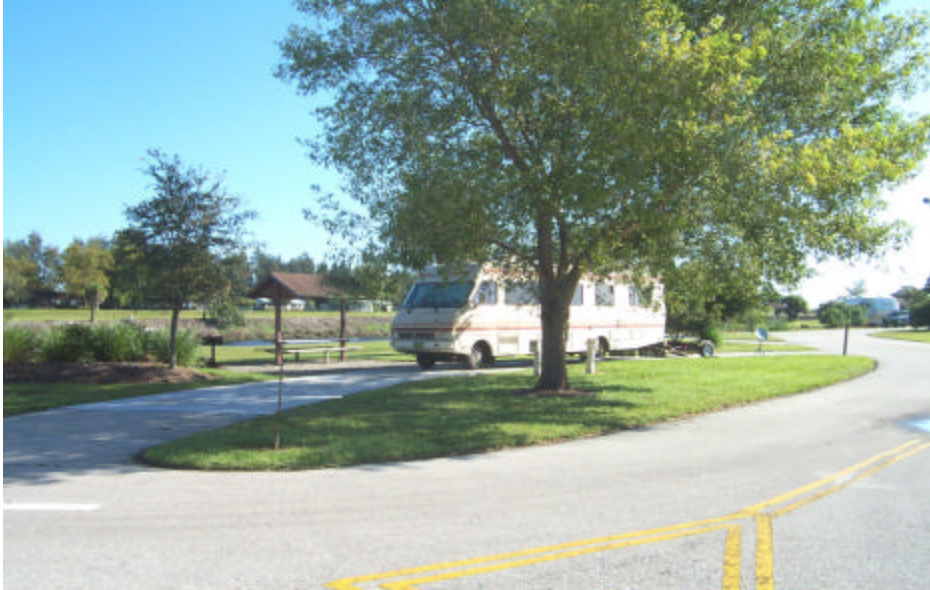
Photo M-11. Pull-through site - double. Ortona South Campground, Lake Okeechobee Waterway, FL. Note landscape plantings for buffer and aesthetics are indigeneous, low-maintenance, sustainable. Shade provided by combination of trees and shelter (Table 5.1)

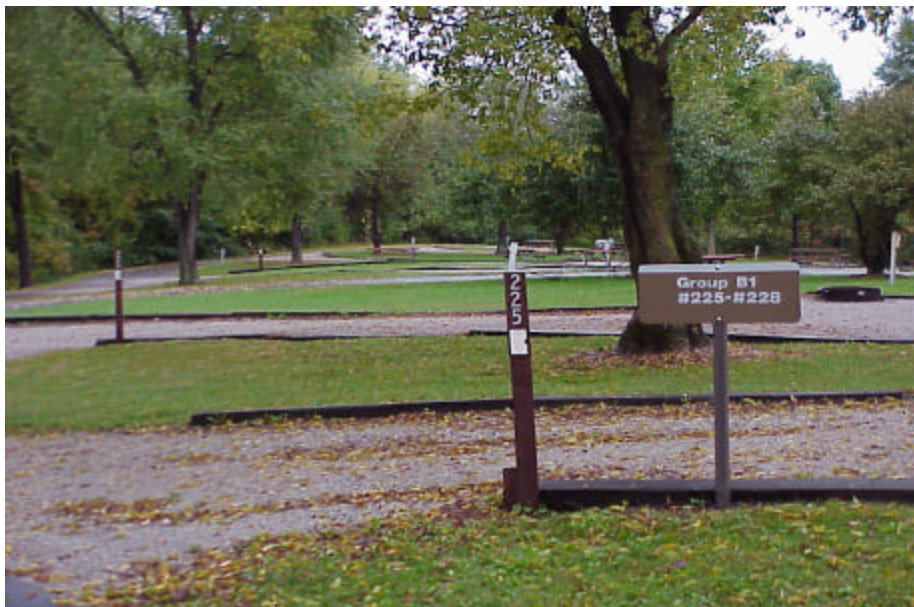
Photo M-12. Group camping area. Sugar Bottom Group Camping Area, Coralville Lake, IA. Where feasible, group campsites may be provided within a campground or in close proximity to an existing campground (Para. 5.3.1.1)

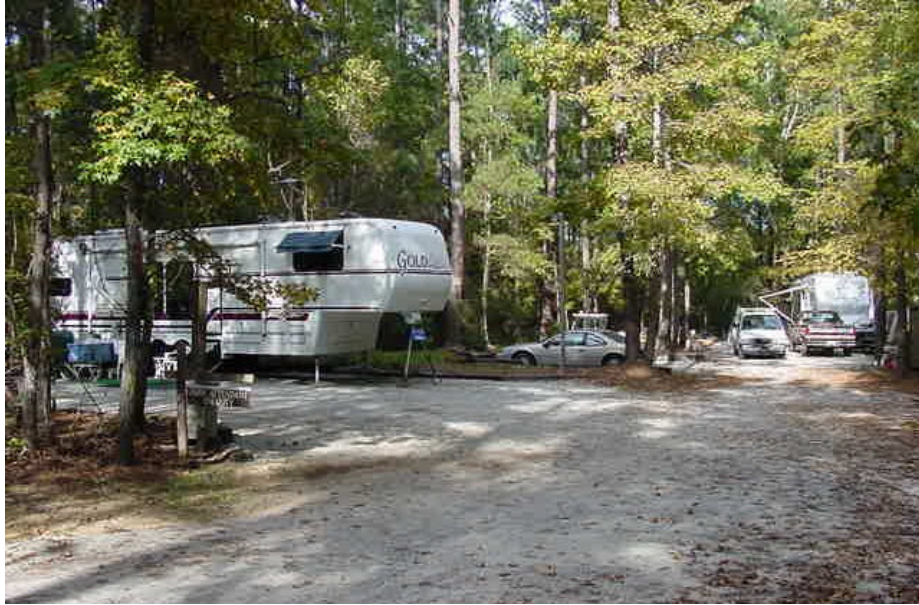
Photo M-13. Park attendant campsite. Petersburg Campground, J. Strom Thurmond Lake, GA. Located near the campground entrance, inside the gates. Vegetation screens living area for privacy. Sign helps campers easily locate attendants in the event of an emergency (Para. 5.3.1.2, Table 5.2)

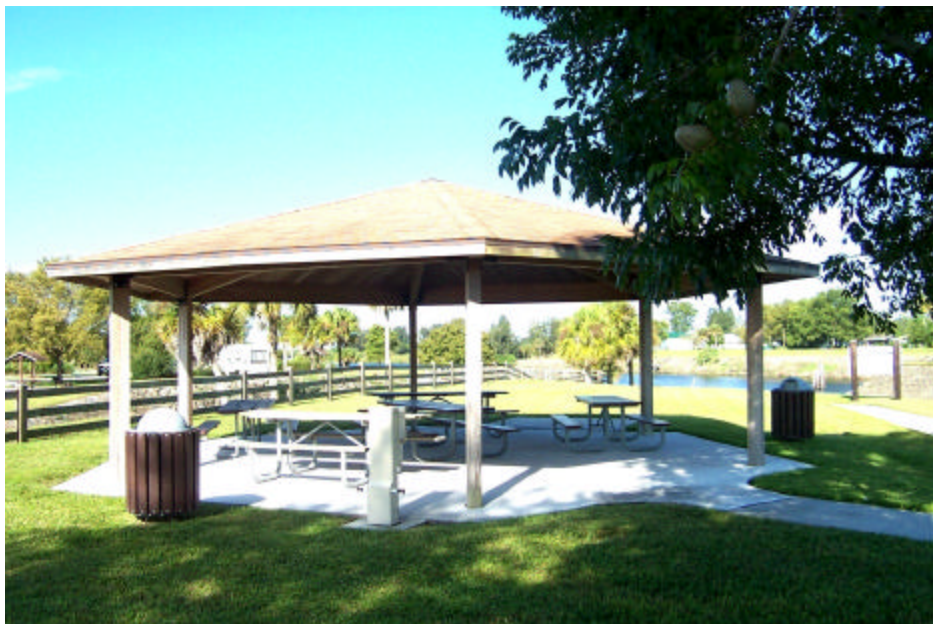
Photo M-14. Group shelter in campground. Ortona South Campground, Lake Okeechobee Waterway, FL. This communal gathering point for campers was constructed after a local Customer Care Survey indicated local demand (Table 5.2, Para. 6.3)

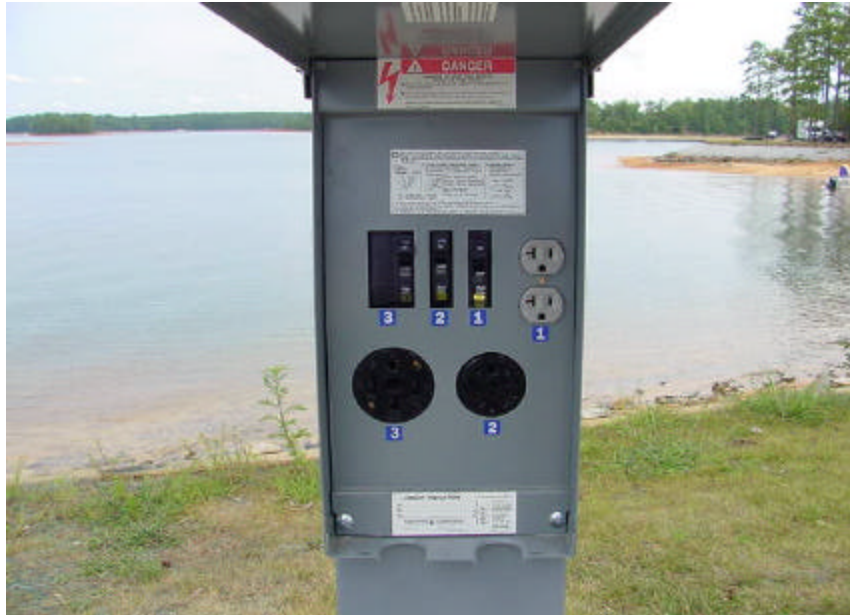
Photo M-15. Electrical Pedestal. Pedestal with 50-, 30-, and 20-amp (GFCI) hookups (Table 5.5)

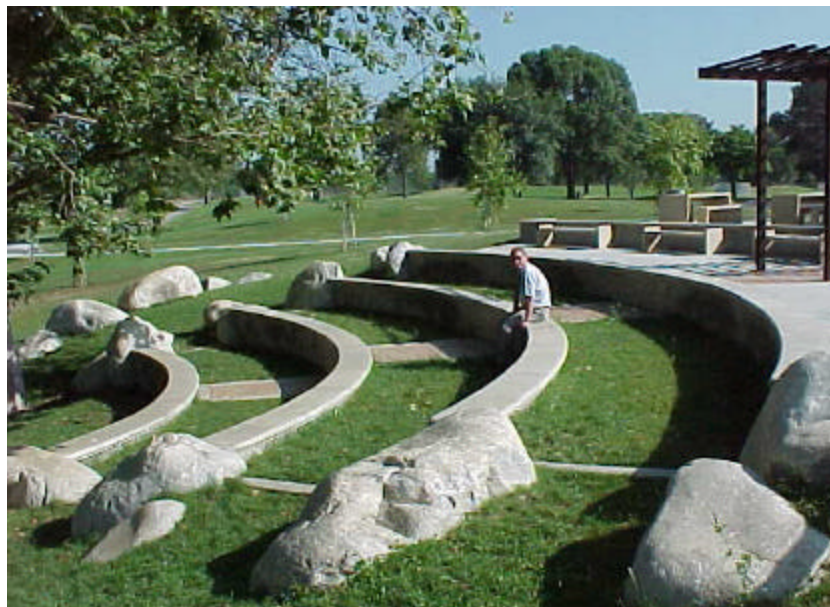
Photo M-16. Low-maintenance amphitheater. City of Los Angeles outgrant, Lake Balboa, Los Angeles District. Amphitheater is constructed of low-maintenance materials that are indigenous to the site. This is an example of a sustainable design. Note that top section is UA (Para. 5.4.8.1)
